Szymon Banaszak

Field Ageing of Composite Traction Insulators

Technical University of Szczecin, Institute of Electrical Engineering 37, Sikorskiego Str., 70-313 Szczecin, Poland E-mail: <u>szymon.banaszak@ps.pl</u>

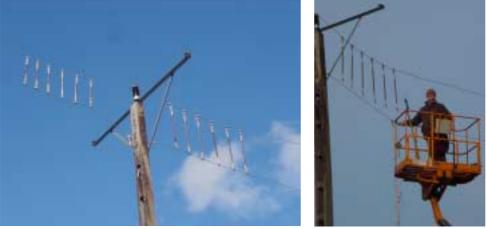
Fig. 3. Insulators mounted in Kołobrzeg-Karsibórz (upper side powered) and connecting measuring equipment.

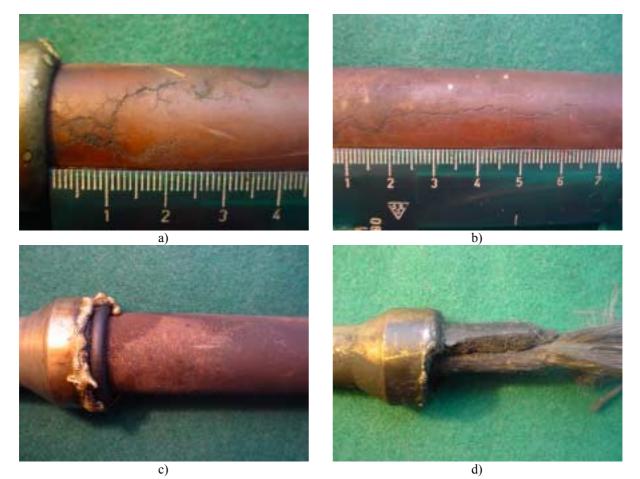
Fig. 4. Insulators heavily damaged during natural ageing. (a), (b) – eroded tracks on the surface, (c) – damaged fitting and the whole surface, (d) – insulator completely burned out.

At the beginning of the December 2004, after approx. 5 months of exposition, some insulators from Dźwirzyno were heavily damaged and demounted. It was caused by first snow, which was very dense and wet and covered the whole surface of insulator dissolving dust and salt particles gathered on it during preceding moths. Constant currents of high values appeared leading to destruction of insulators. This failure wasn't planned and some results of natural ageing for longer time are lost, but from the other hand, very good example of intensive natural ageing was achieved in short period of time. Pictures below present surface and interior of damaged insulators. For one of them only surface of housing material was damaged, but for other one housing material was completely burned out.
